TOP NOTCH BUILDING

Feasibility Study and Analysis

Prepared by
Alley Poyner Macchietto Architecture
and Field Day Development
October 2014

EXISTING BUILDING CONDITIONS

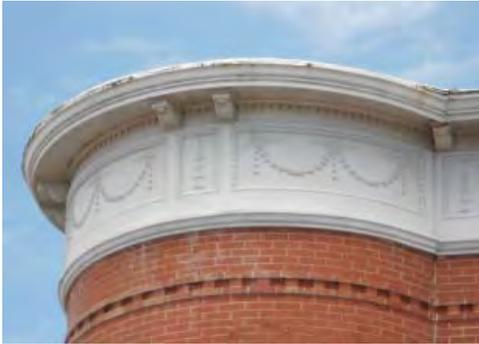
Upper metal cornice with classical details.
Photo taken by APMA - June 2014.

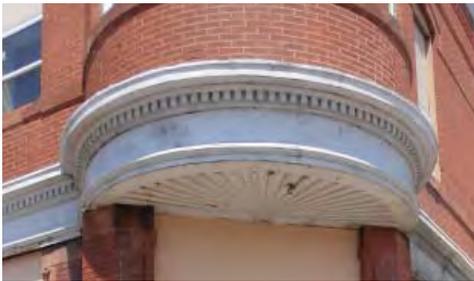
Lower metal cornice and pressed metal ceiling on bottom of turret.
Photo taken by APMA - June 2014.

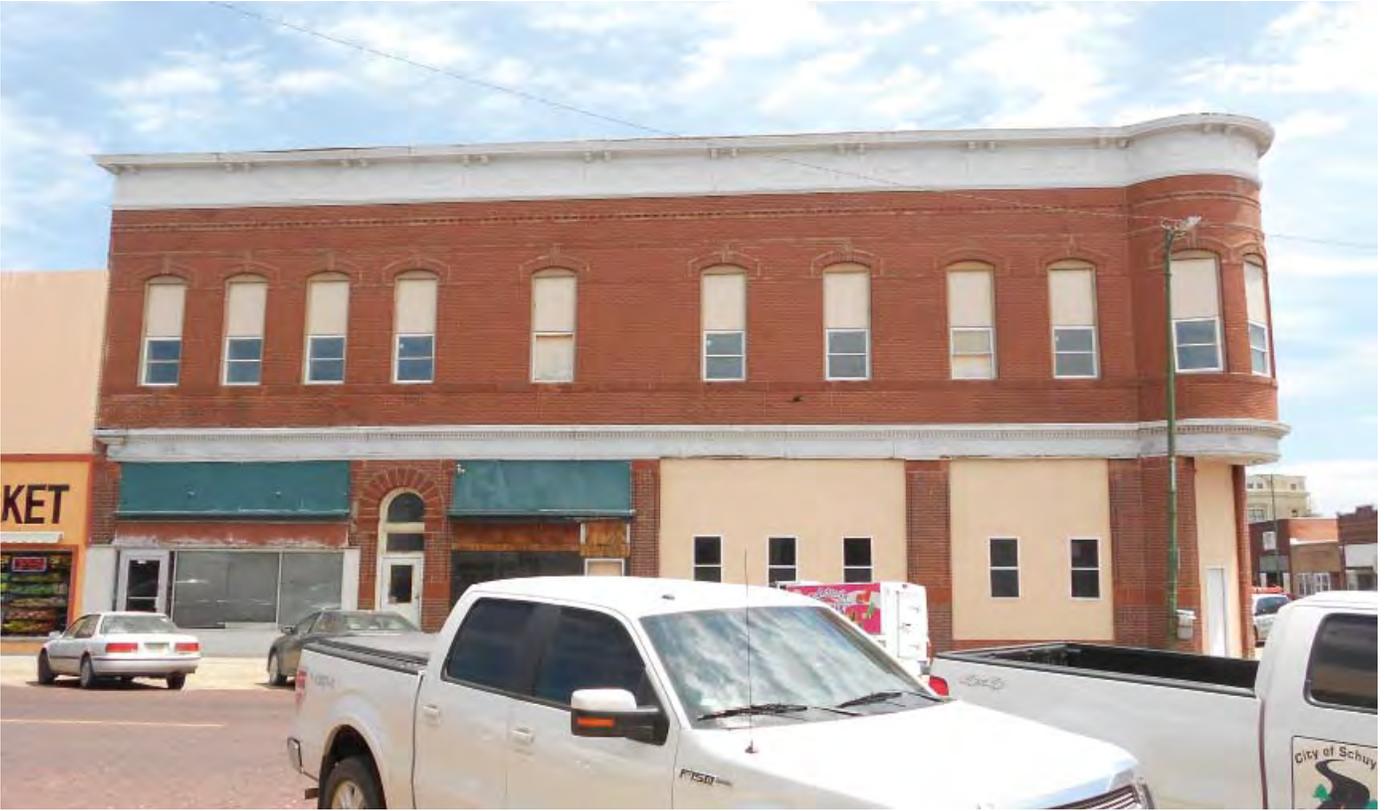
Exterior - West facade of building (B Street). Photo taken by APMA - June 2014.

The B Street **west facade** consists of four, first floor tenant bays. The north two bays have been infilled with modern aluminum storefront systems while the south two bays have been infilled with brick bases and stud wall construction finished with painted plywood. However, historic colonettes continue to frame the storefront openings. A secondary entrance which provides direct access to the second floor is located between the two north bays. Although modified slightly, this entrance retains much of its historic integrity. Another surviving historic element is the prismatic glass transom found above the storefront in the bay just south of the historic, west entrance.

The second floor consists of nine, historic window openings. The original wood windows have since been replaced with a small one-over-one double hung vinyl window in the bottom sash and a piece of plywood to infill the upper sash. The middle window opening remains completely infilled. All of the vinyl windows are operable and in good condition.

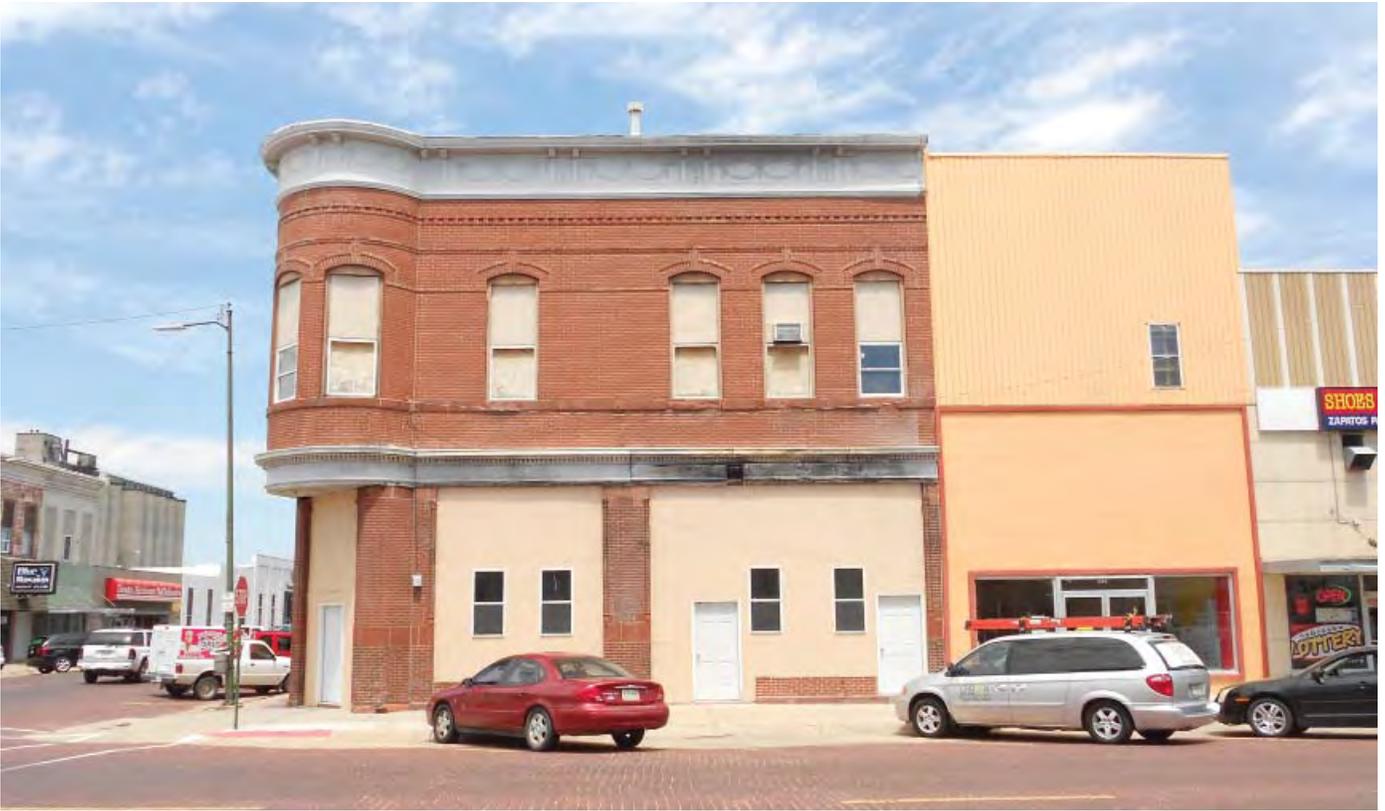
Exterior - South facade of building (11th Street). Photo taken by APMA - June 2014.

The 11th Street **south facade** consists of two, first floor tenant bays. Both bays have been infilled with brick bases and stud wall construction finished with painted plywood. Two, solid doors in the east bay provide access into the east bay on the first floor. The infilled storefronts each have two vinyl windows. Similar to the west facade, historic colonettes continue to frame the storefront openings. The lower metal cornice is in poor condition on this facade due to damage from the 2010 fire.

The second floor consists of four, historic window openings. The original wood windows have been replaced. The west three window openings have been infilled with plywood. The east window opening has a small one-over-one double hung vinyl window in the bottom sash and a piece of plywood to infill the upper sash.

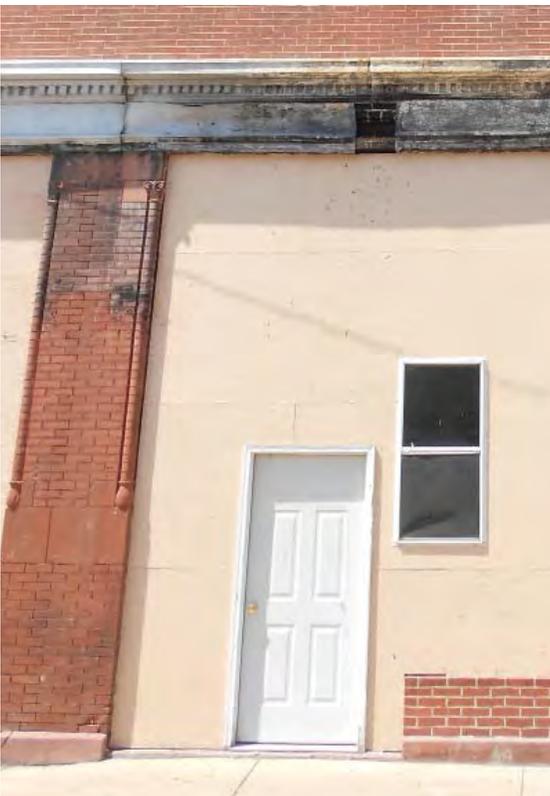
Colonettes along storefront edges and damaged metal cornice. Photo taken by APMA - June 2014.

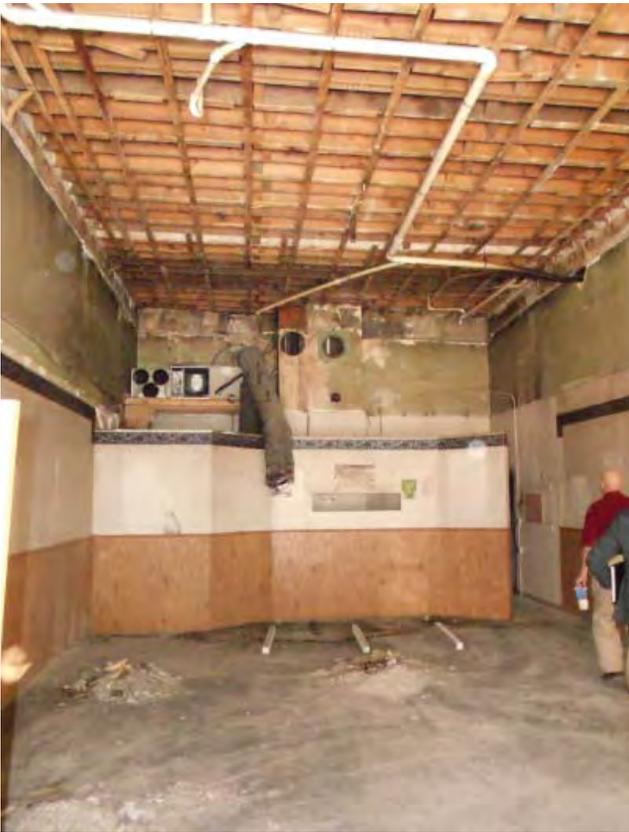
A fire in 2010 charred the masonry walls and wood flooring members on the first floor. Modern flooring materials such as carpet, linoleum, and wood flooring remain but are in poor condition.

Interior - North commercial bay on first floor.
Photo taken by APMA - June 2014.

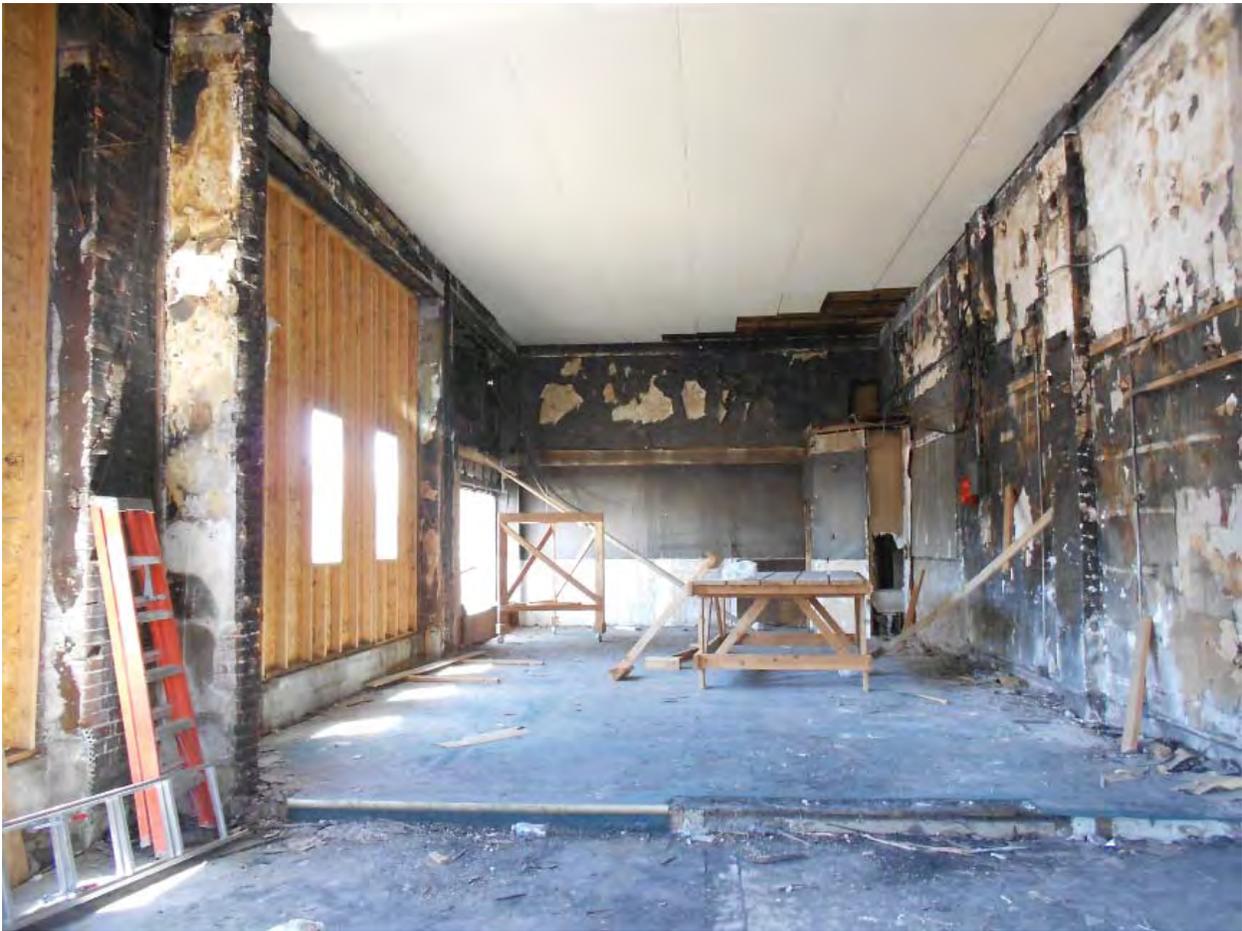
Interior - West commercial bay on first floor. Photo taken by APMA - June 2014.

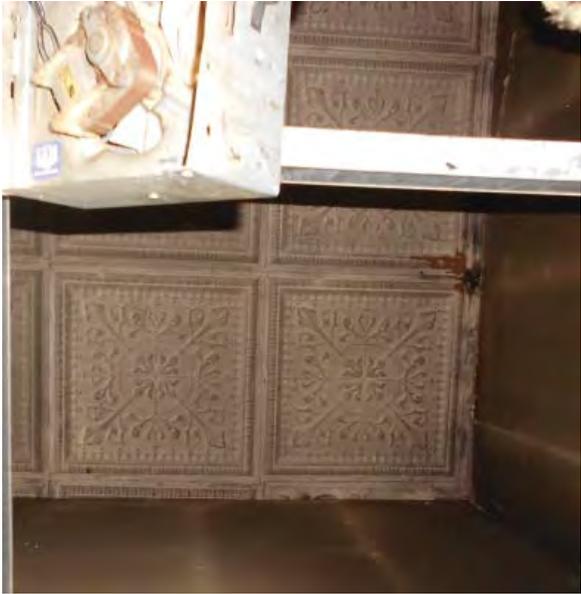
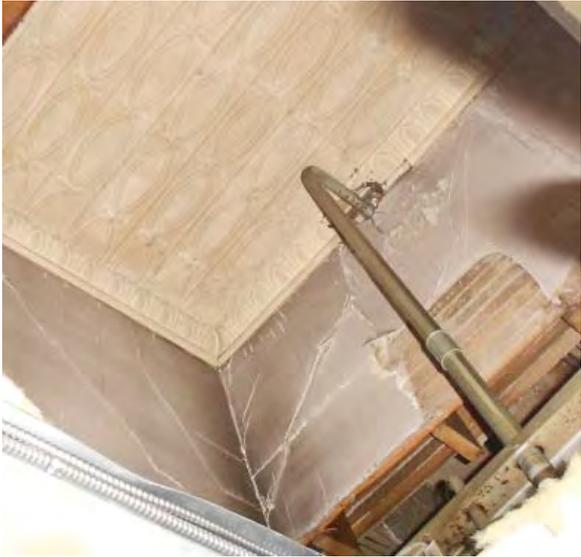
Interior - Two different patterns of pressed metal ceiling found in existing Unit 1 (top) and existing Unit 2 (bottom). Photos taken by APMA - June 2014.

A pressed metal ceiling, found in two different patterns and accompanied by a small crown molding, remains above the modern dropped ceiling system. It is uncertain how much of the metal ceiling remains on this floor.

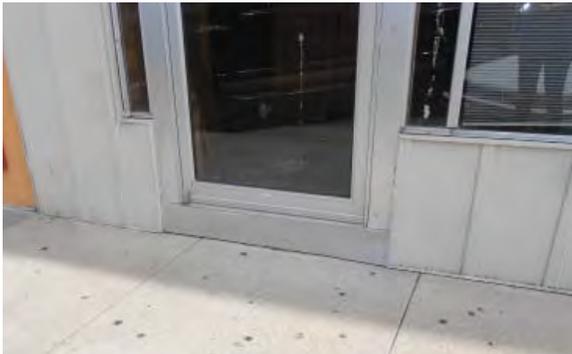
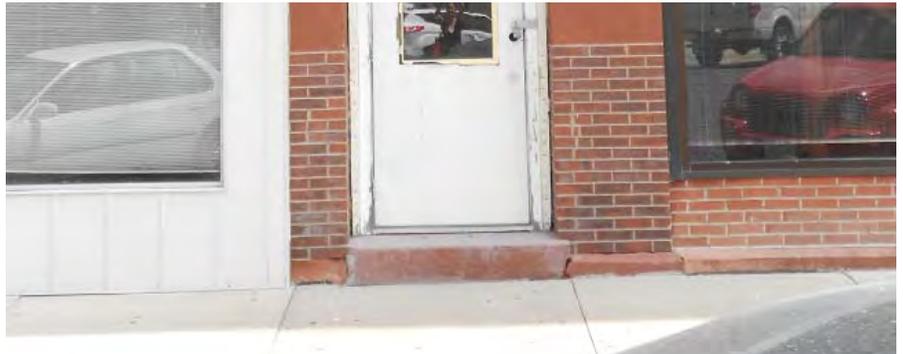
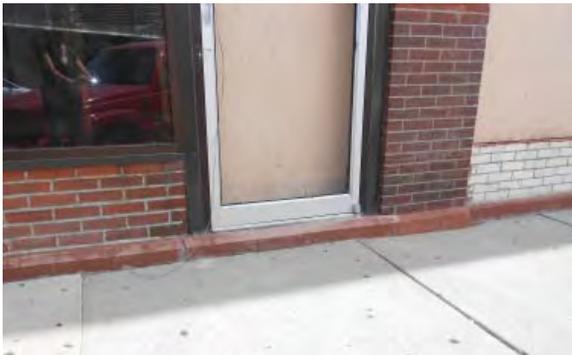
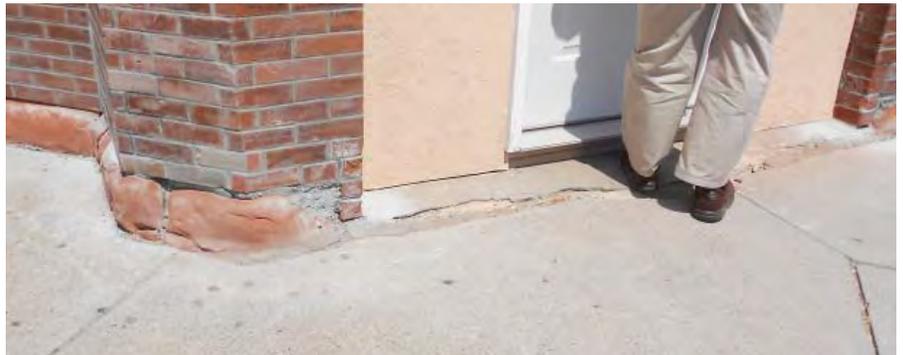
The change in elevation across the west and south facades will need to be addressed in terms of accessible requirements. Ramps on the exterior and interior can help resolve these issues.

Elevation changes at west facade entrances and at main corner entrance. Photo taken by APMA - June 2014.

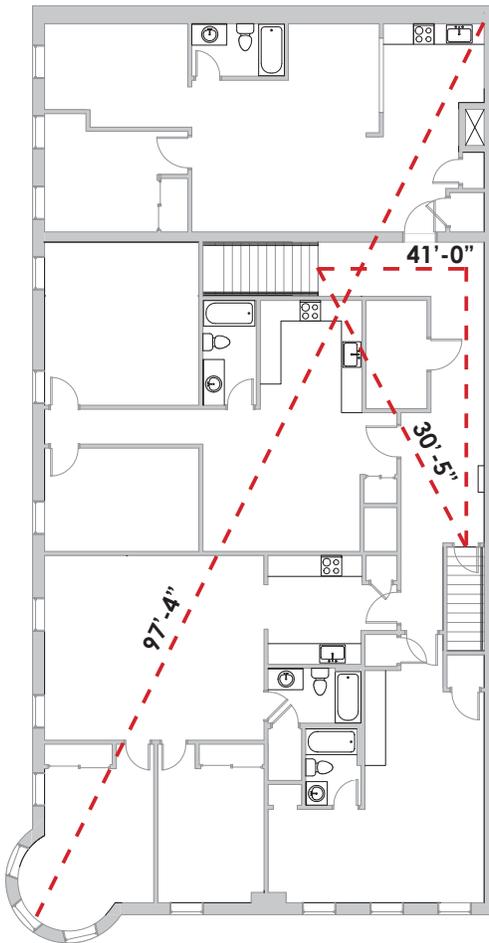
Diagram of existing second floor plan showing distance between current stairways.
