TOP NOTCH BUILDING

Feasibility Study and Analysis

Prepared by
Alley Poyner Macchietto Architecture
and Field Day Development
October 2014

EXISTING BUILDING CONDITIONS

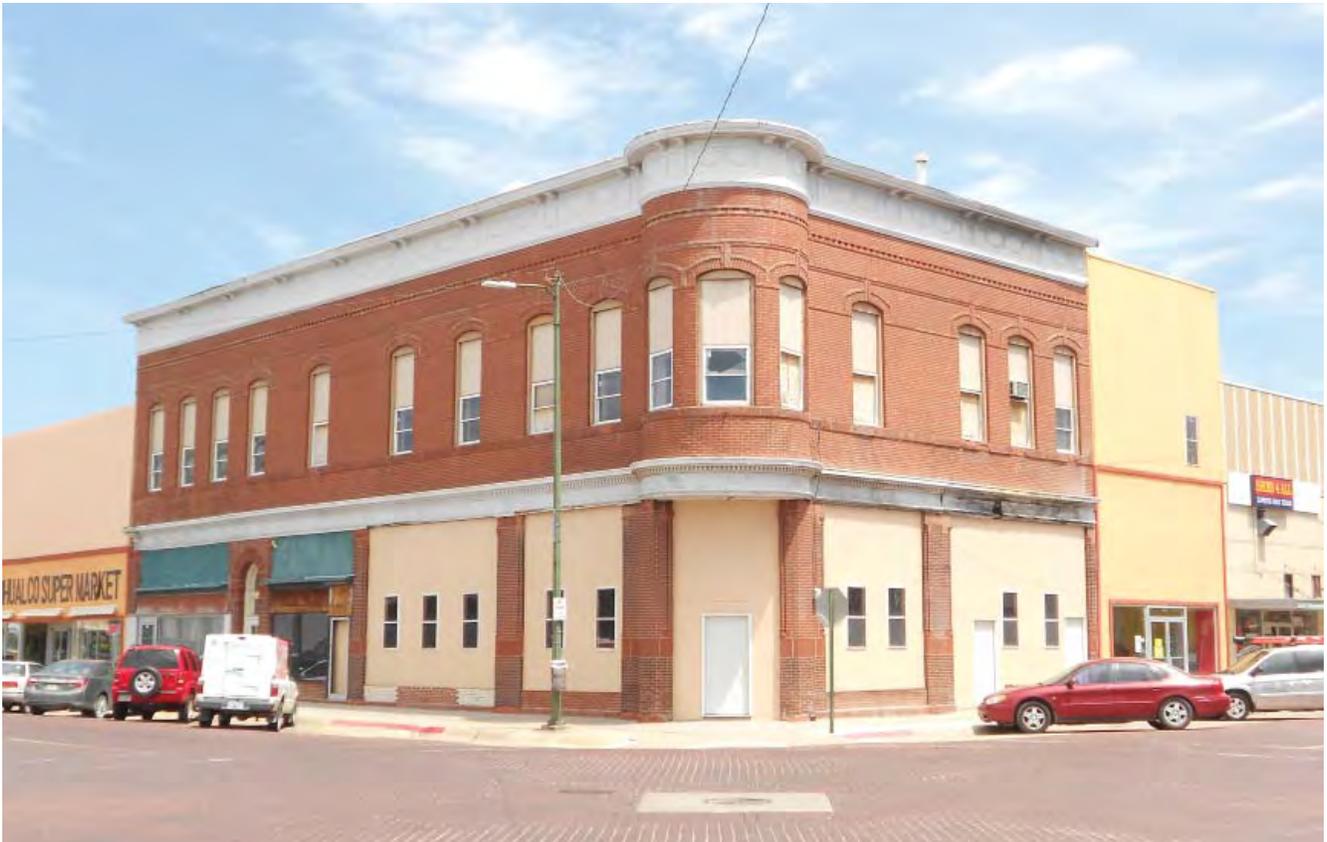
The main entrance, set at a diagonal, is located on the street corner and situated beneath the corner turret, which projects outwards at the second floor. A pressed metal ceiling remains on the bottom of the turret in good condition. The main entrance has endured many modifications throughout the years. Currently, the main entrance opening is infilled with stud wall construction and painted plywood. A solid door, centered within the opening, provides access into the west bay of the first floor.

Exterior - Corner view of building. Photo taken by APMA - June 2014.

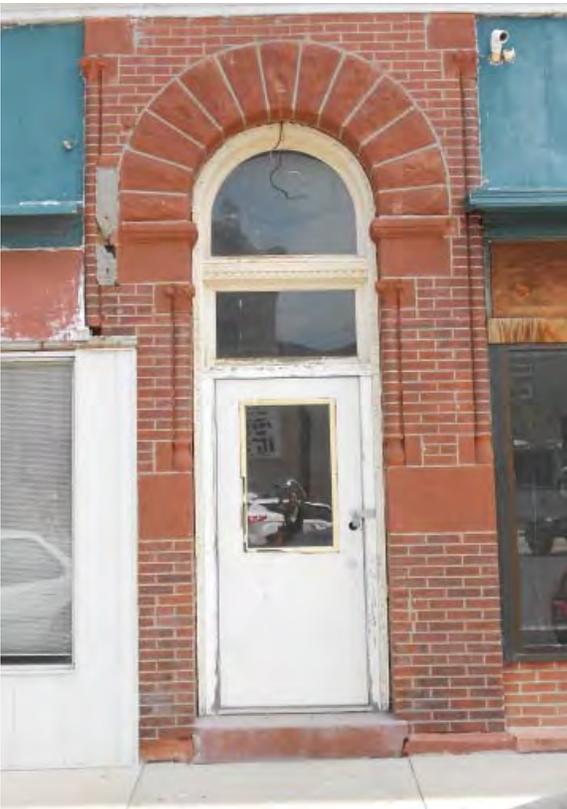
West (B Street) entrance to second floor with stone door surround, colonettes, and arched glass transom window. Photo taken by APMA - June 2014.

The B Street **west facade** consists of four, first floor tenant bays. The north two bays have been infilled with modern aluminum storefront systems while the south two bays have been infilled with brick bases and stud wall construction finished with painted plywood. However, historic colonettes continue to frame the storefront openings. A secondary entrance which provides direct access to the second floor is located between the two north bays. Although modified slightly, this entrance retains much of its historic integrity. Another surviving historic element is the prismatic glass transom found above the storefront in the bay just south of the historic, west entrance.

The second floor consists of nine, historic window openings. The original wood windows have since been replaced with a small one-over-one double hung vinyl window in the bottom sash and a piece of plywood to infill the upper sash. The middle window opening remains completely infilled. All of the vinyl windows are operable and in good condition.

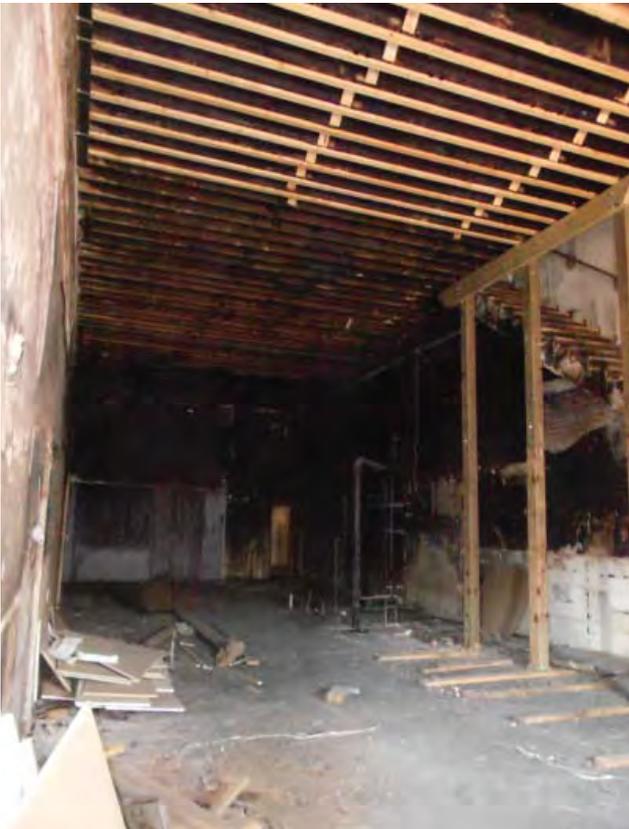
A fire in 2010 charred the masonry walls and wood flooring members on the first floor. Modern flooring materials such as carpet, linoleum, and wood flooring remain but are in poor condition.

Interior - East commercial bay on first floor.
Photo taken by APMA - June 2014.

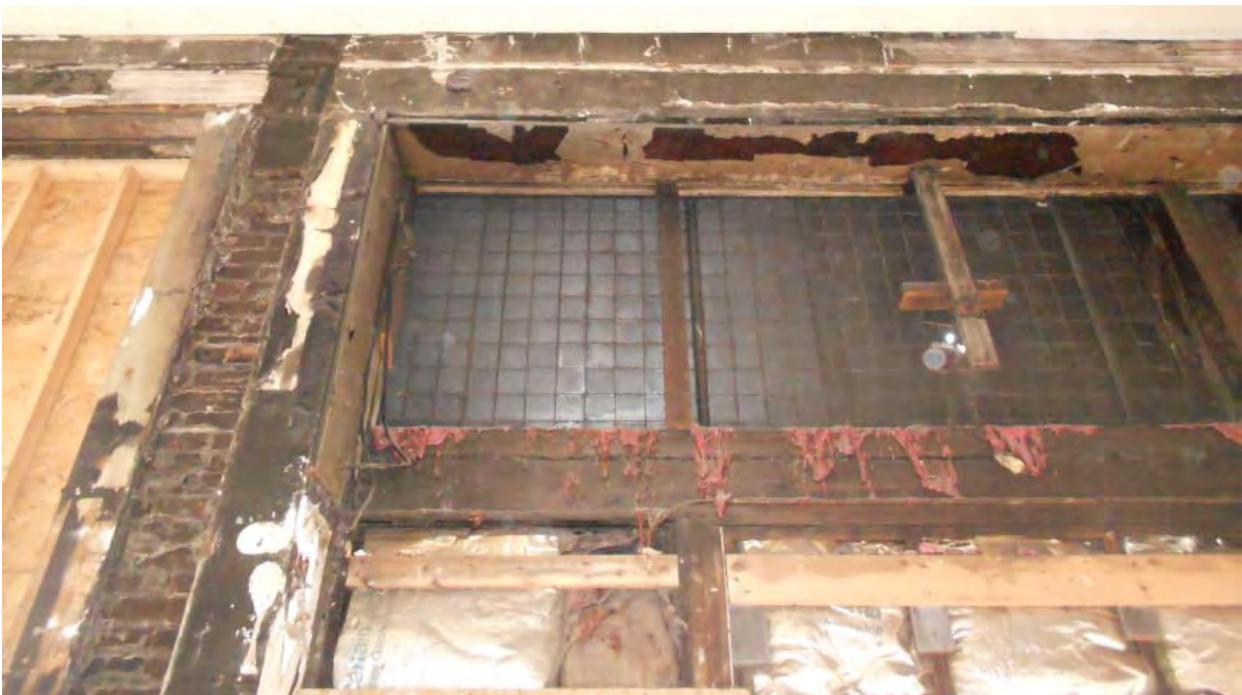
Interior - Prismatic glass transom above display window in west commercial bay on first floor. Photo taken by APMA - June 2014.

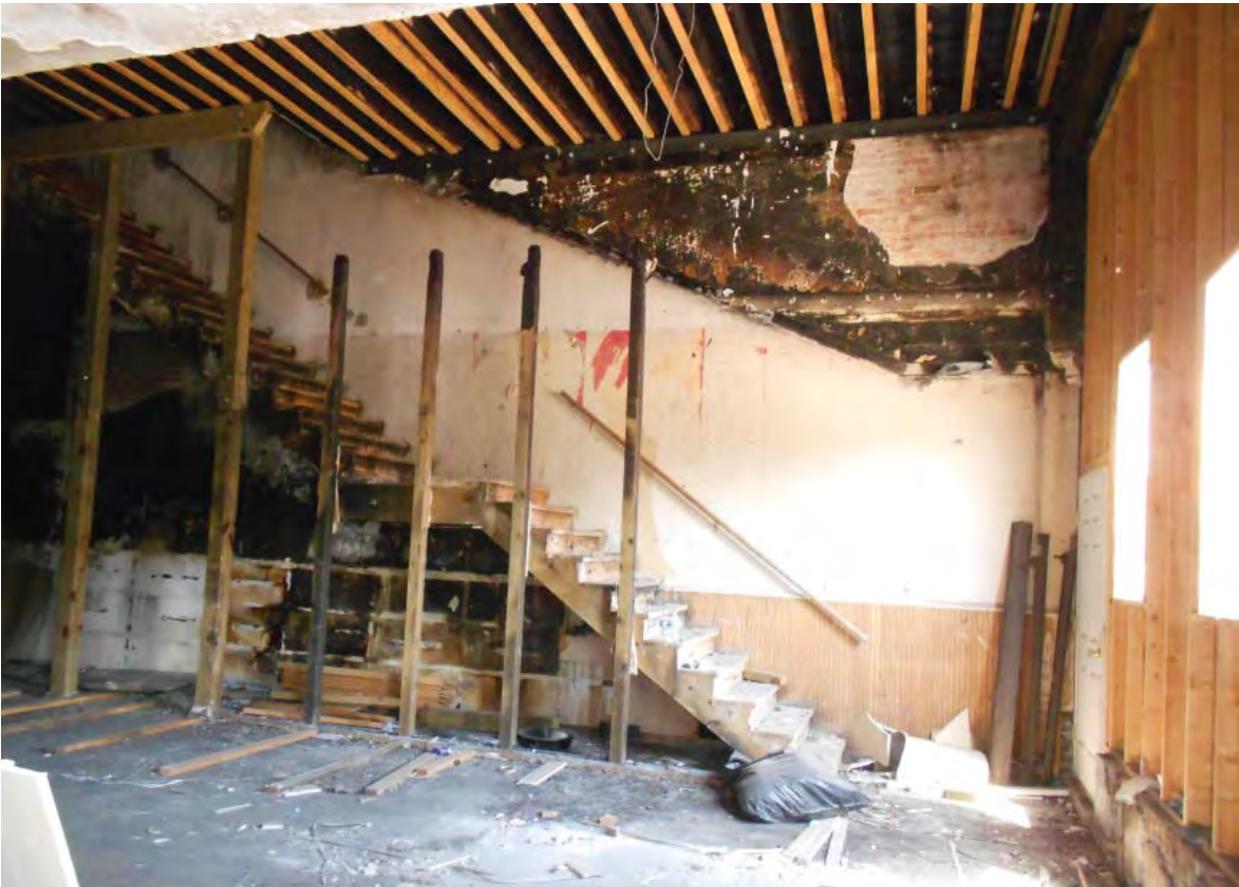
Interior - South stair along east wall in east bay. Photo taken by APMA - June 2014.

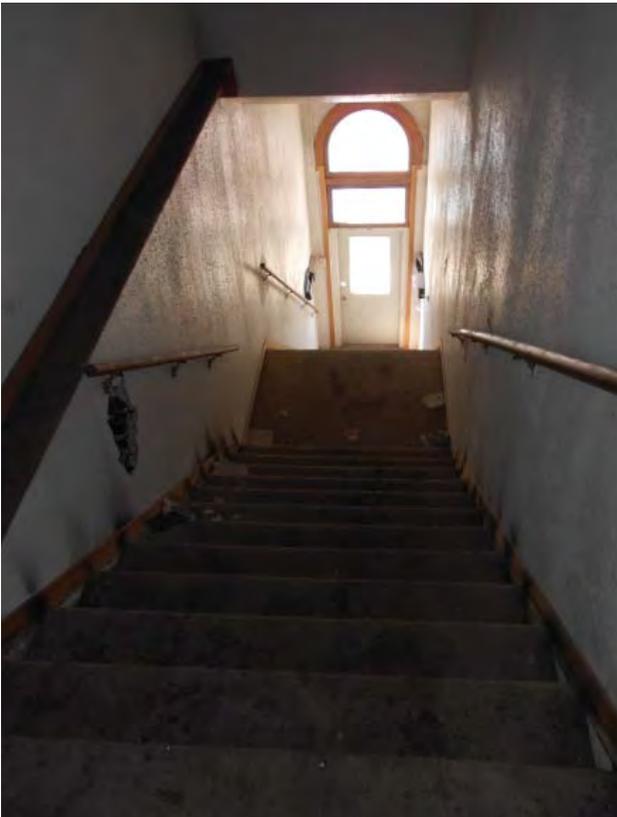
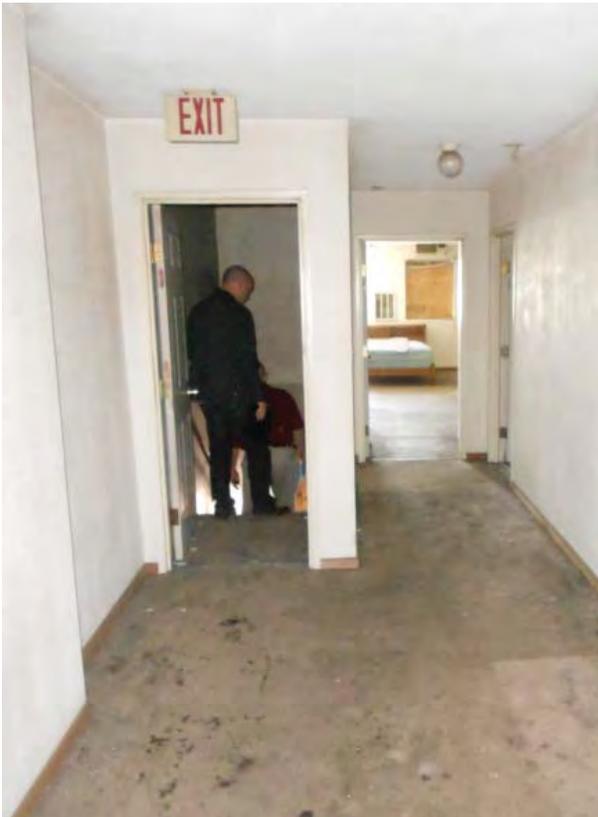
Interior - (Left) North stairwell. (Right) Top of south stair from public corridor. Photo taken by APMA - June 2014.

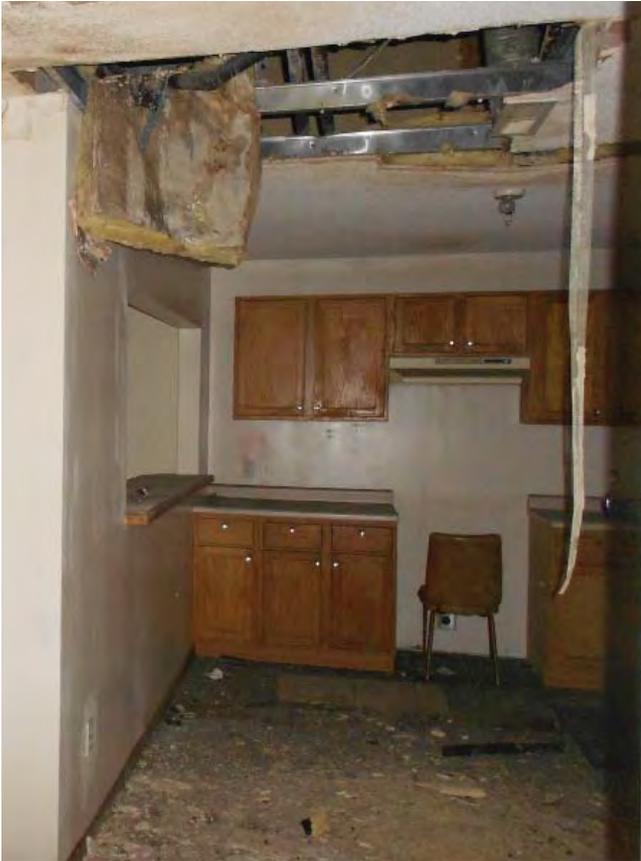
The **second floor** can be divided into two separate areas: the north bay and south bay. Currently, the north bay is composed of one apartment. The south bay consists of three apartments, two public stairs, and a public corridor. All apartments are currently vacant and show signs of deterioration. Minor damage from several water leaks requires repair throughout much of the second floor ceiling. Even though the building's roof was replaced in 2013, abatement of any lingering odors or mold needs to be addressed prior to future occupancy.

Interior - Existing Unit 4 apartment on second floor.
Photo taken by APMA - June 2014.

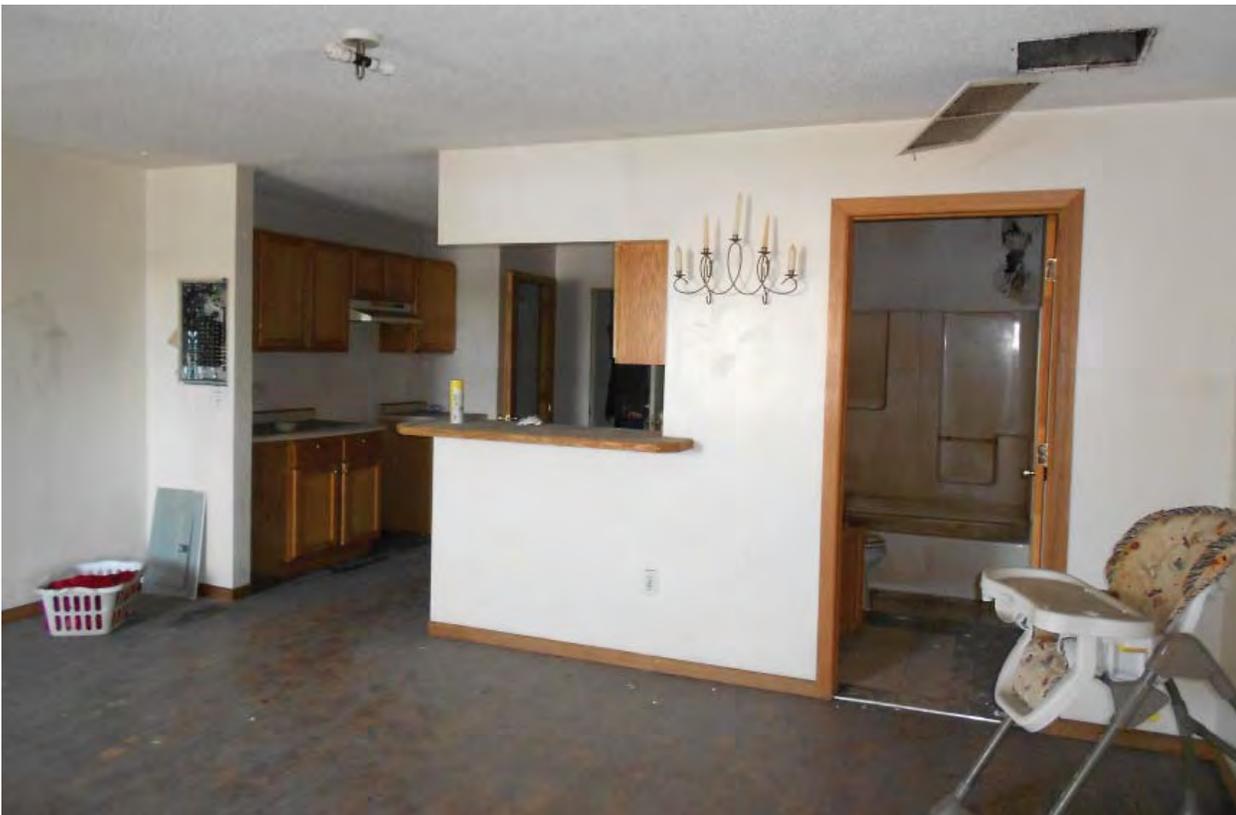
Interior - Existing Unit 2 apartment on second floor. Photo taken by APMA - June 2014.

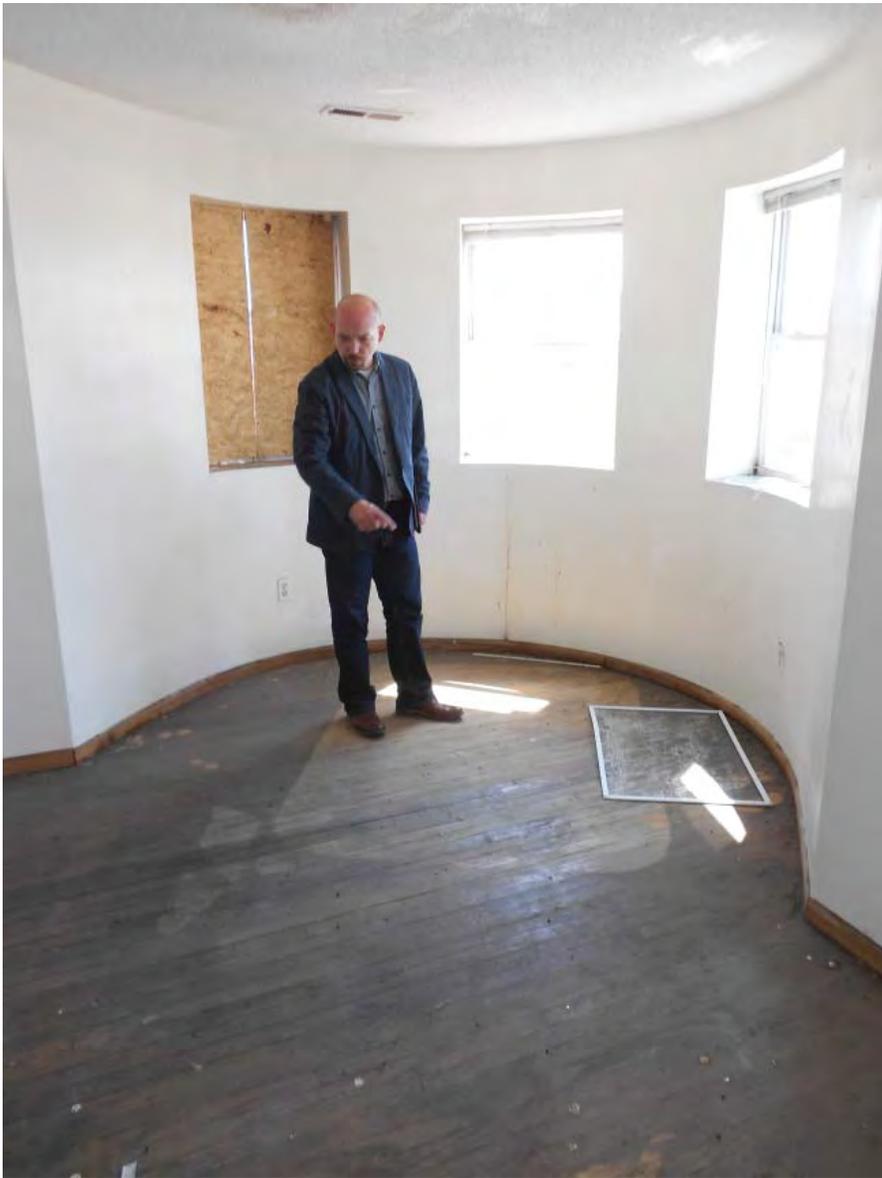
Interior - Existing Unit 2 apartment on second floor with wood floor. Photo taken by APMA - June 2014.
